Early Responses to Runnels in Southern New England Salt Marshes

A technical report on results from a collaborative experiment testing the efficacy of runnels, an emerging climate adaptation tool, in Buzzards Bay.

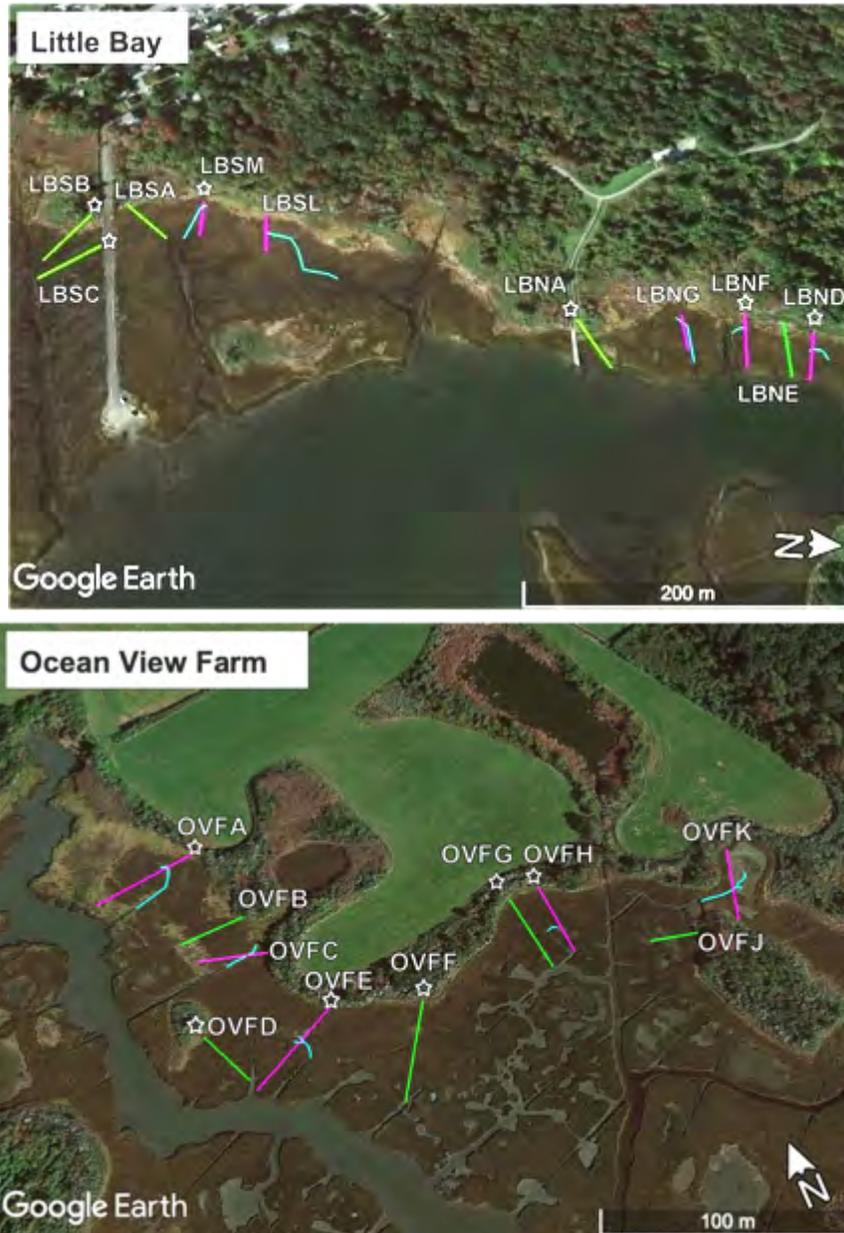
Figure 1. Site maps of LB and OVf. Green lines represent sampling transects at reference sites, and purple lines indicate sampling transects at runnel sites. Light blue lines illustrate the runnels created in October and November 2020. The stars indicate the intensive sites. All reporting in this document focuses on the intensive sites only.

Little Bay Marsh in Town of Fairhaven and Ocean View Farm in Town of Dartmouth were selected as study marshes (Figure 1). These two marshes are both protected lands with protected upland space to migrate, have supportive landowners with whom we partnered, and are located in towns where we had municipal, public, partner, and county mosquito control support to initiate and maintain the project. These marshes have both been historically ditched, and have many shallow water areas present that appear to have formed recently.
